Science Lab Initiative
Nashoba Regional High School
Bolton, Massachusetts

JULY 23, 2012

SMMA NO. 12060.00

PRELIMINARY DESIGN PROGRAM

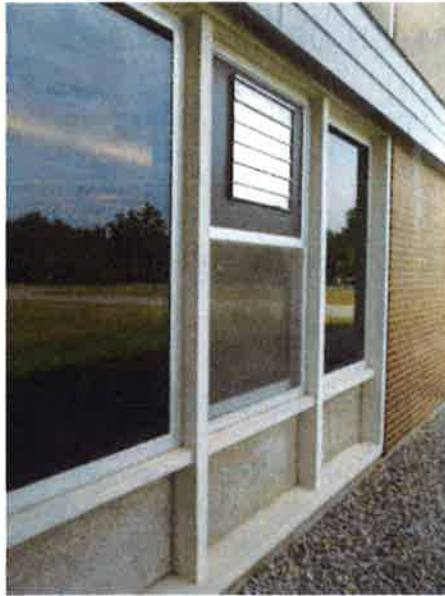
EXTERIOR WALLS

The exterior walls are a mix of masonry wall and pre-cast panels. The masonry construction appears to be constructed of 4" brick veneer with 8" masonry backup. Considering the time of construction, cavity wall construction was not a very common practice. Therefore we believe there is no insulation or very little insulation present in the walls. The masonry is in generally good condition inside and out. The pre-cast panels are 5" thick with 1" of rigid insulation in the core. The foundation wall where exposed to view appears to be in good condition.

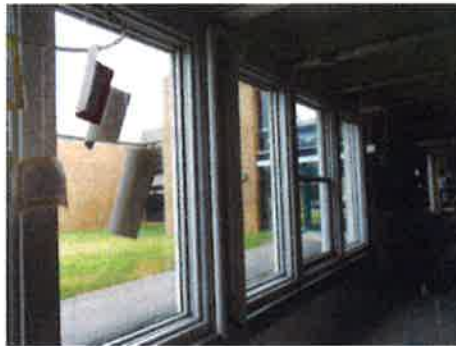
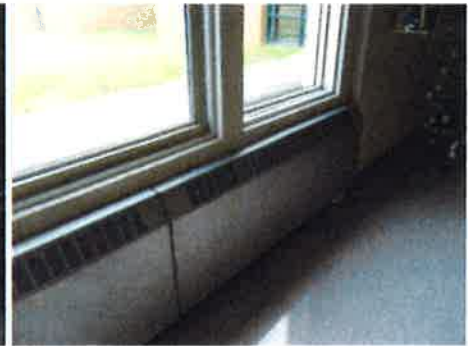
EXTERIOR WINDOWS

The windows are single glazed strip windows with operable vertical sliding window units. The windows are generally fair to poor in condition and do not comply with current energy code and will require replacement with thermally broken insulated units. Windows sills are aluminum.

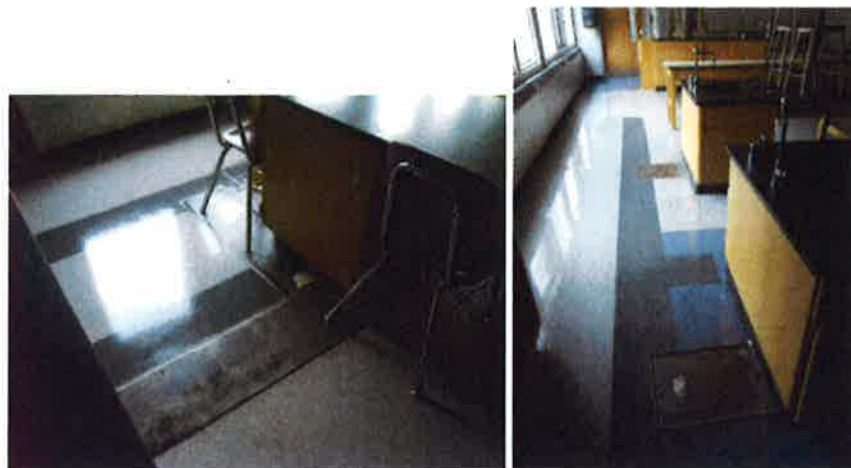
FLOORING

Classrooms have resilient floor tiles (VCT) and are in fair condition.

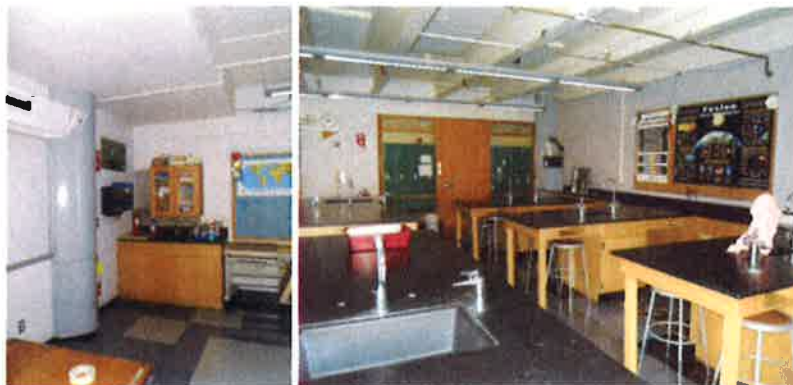
CASEWORK

Science room casework is original and does not meet accessibility standards or current lab needs. It shall be replaced as part of this project and brought up to ADA/MAAB accessibility standards and requirements.

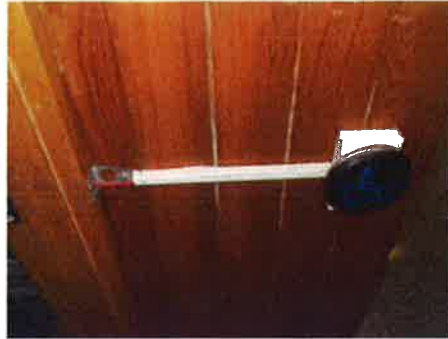
GENERAL ACCESSIBILITY ISSUES

Many of the classroom entrance doors are without the necessary side maneuvering clearances required to meet accessibility code. Door operators were installed but were not functioning at most locations. In some instances the closer arms were severed and at others the operators were not powered.

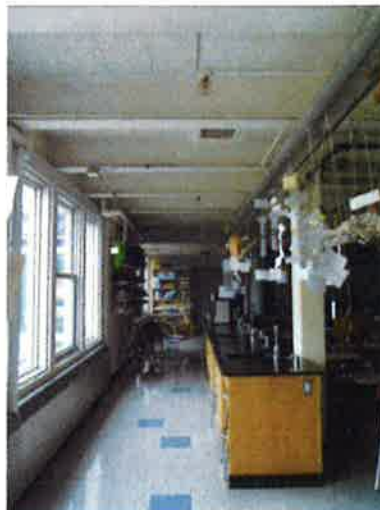
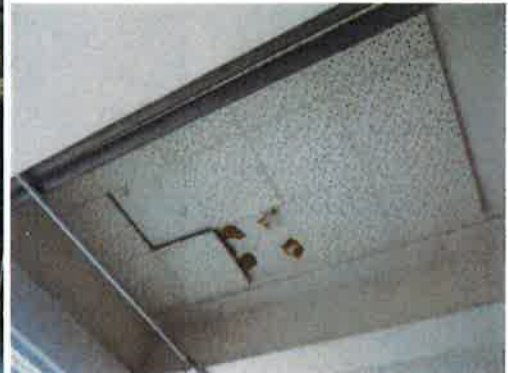
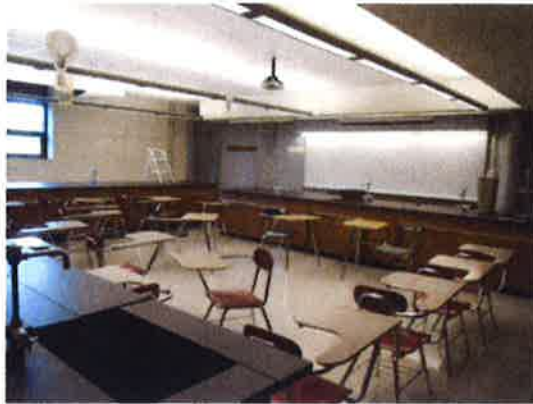
**CEILINGS**

Classrooms in the 'junior wing' have no ceilings and are exposed to the structure with acoustic panels applied to the underside of structure. Classrooms in the 'senior wing' have an acoustical ceiling, 2x4, at 9'-6" above finished floor.
